Television Coaxial Connector Replacement

The cable connector was pulled out of the back of the TV, disassembled and repaired.

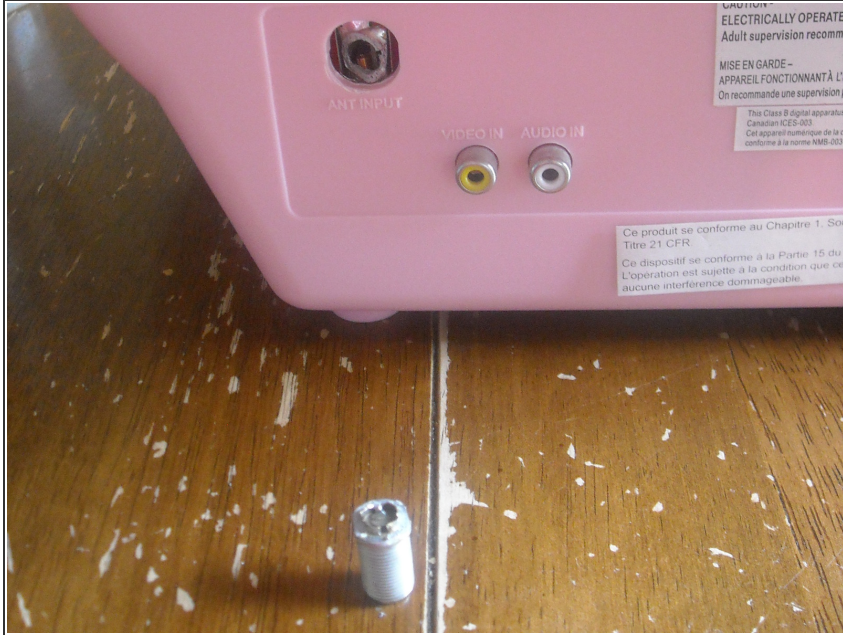
Step 1 — Coaxial Connector

- Kids pulled the cable connector off the back of the hello kitty TV

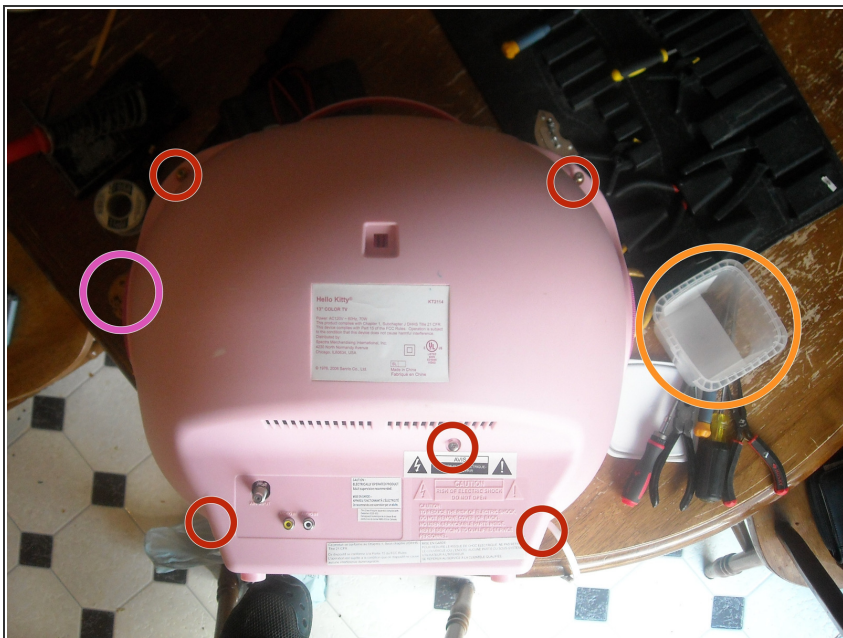
Step 2

- Remove screws from back, there's 5 in this case circled in red.
- Notice the parts container highlighted in orange always a good idea for screws.
- Cookie circled in pink for good measure.
